Workmanship Standards *for* Licensed Contractors

JUNE 2009

**STATE OF ARIZONA
REGISTRAR OF CONTRACTORS**

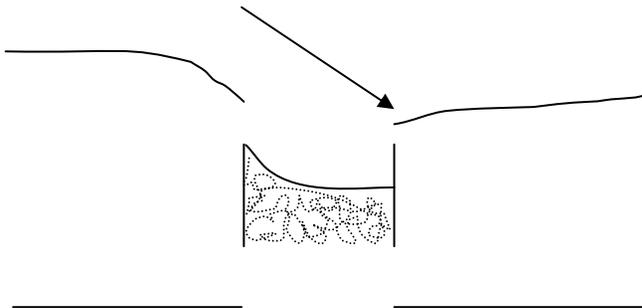
- 8. PD Missing or irregular grout.
AT None. Grout should be flush to the top edge of the adjacent tile.
CR Contractor should make necessary repairs.

Exposed vertical face of tile is unacceptable

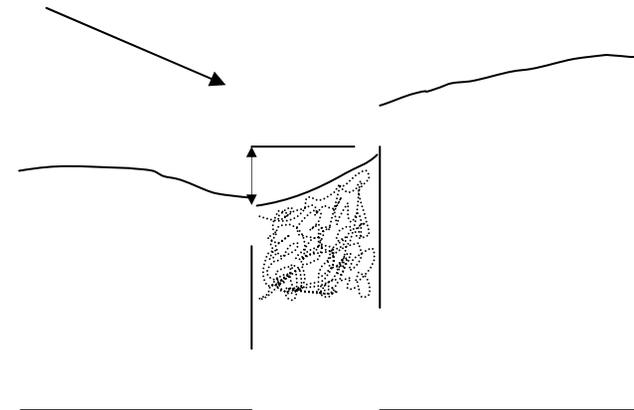
5. PD Uneven tiles.
AT Lippage of more than 3/16" is unacceptable. Inherent characteristics of the tile dictate the method of installation of the tile. All unusual characteristics of the tile should be explained to the owner or the owner's agent prior to installation.
CR Contractor should make necessary repairs.

Lippage of more than 3/16" is unacceptable
